POL PIER REPAIRS  
LAJES FIELD , AZORES

FINAL FIELD INSPECTION REPORT  
FEBRUARY 1983

POL PIER REPAIRS  
LAJES FIELD, AZORES  
CONSTRUCTION INSPECTION VISIT NO. 4  
JUNE 4 TO JUNE 10, 1981  
CONTRACT NO. N-62477-79-C-0021  
MODIFICATION P-00003

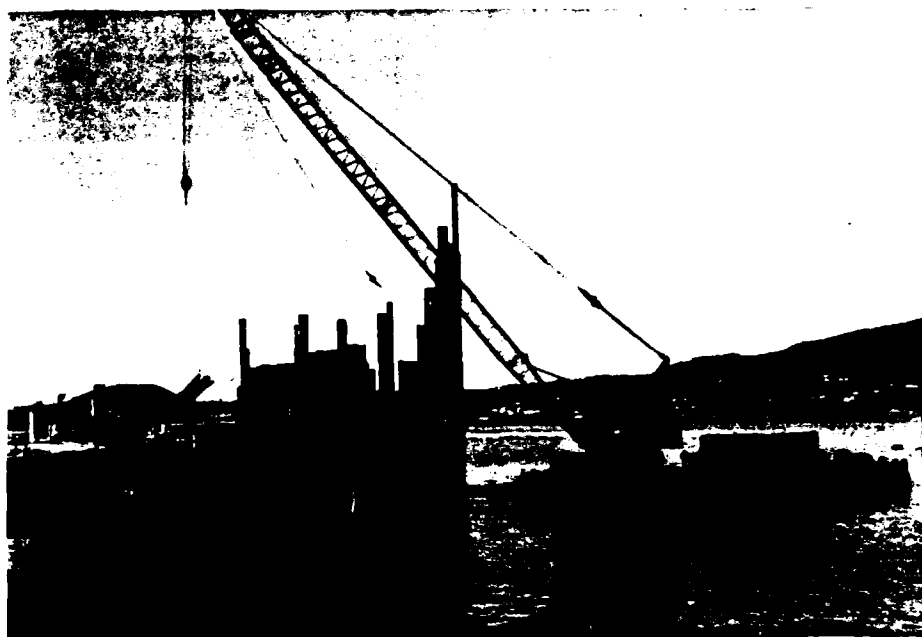
NEW NORTH DOLPHIN  
Threading the West Wall and Driving at the Other  
Three Walls to Level the Sheet Piles

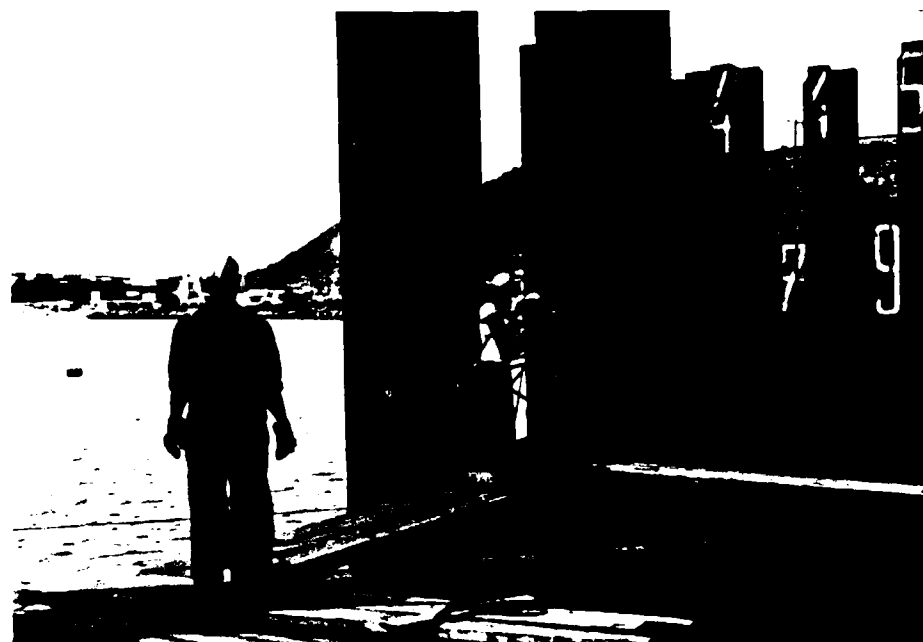
NEW NORTH DOLPHIN  
Threading Sheets at the North End of the West Wall.  
The Other Three Walls Have Been Partially Driven.

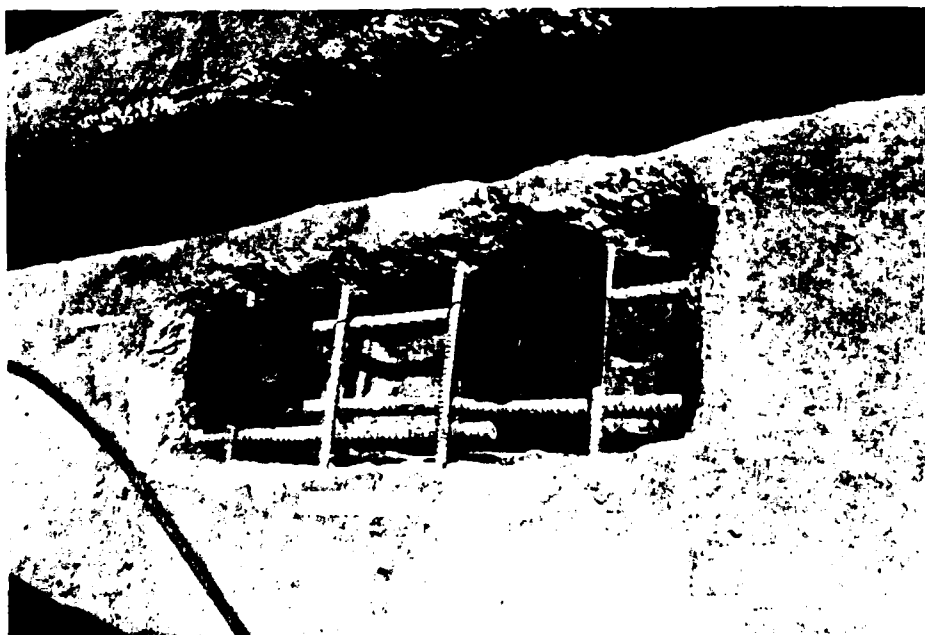
#### LOADING PLATFORM

Angle Plates, for Batter Pile Tie Down, to be Placed Beneath Reinforcement.

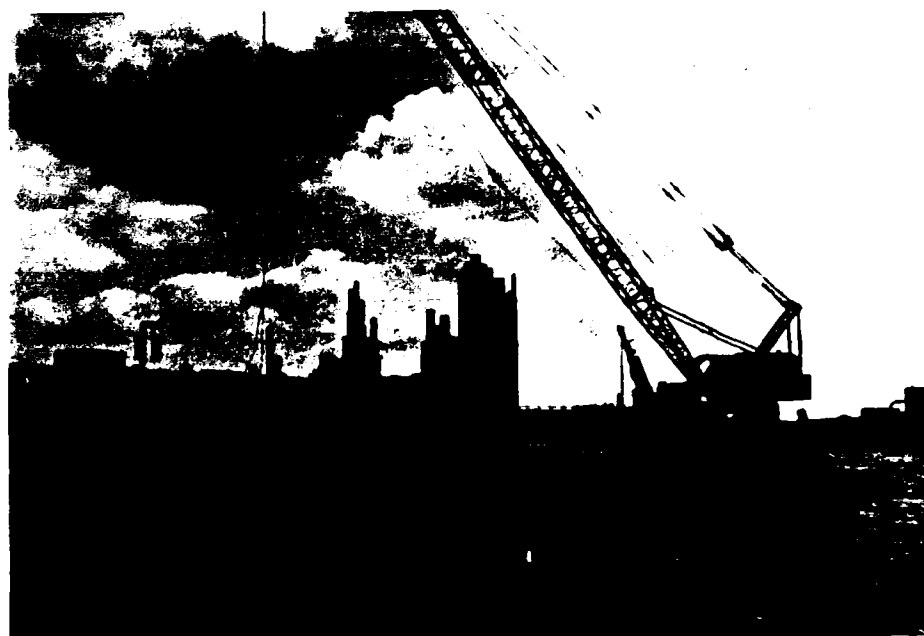
LOADING PLATFORM AND NEW SOUTH DOLPHIN  
Overall View Looking Southeast. Note Uniform Sheet  
Pile Cut Off at South End of Loading Platform Fen-  
der Sheeting. Note Non-Uniform Driving and Thread-  
ing of Sheet Piles for the New South Dolphin.

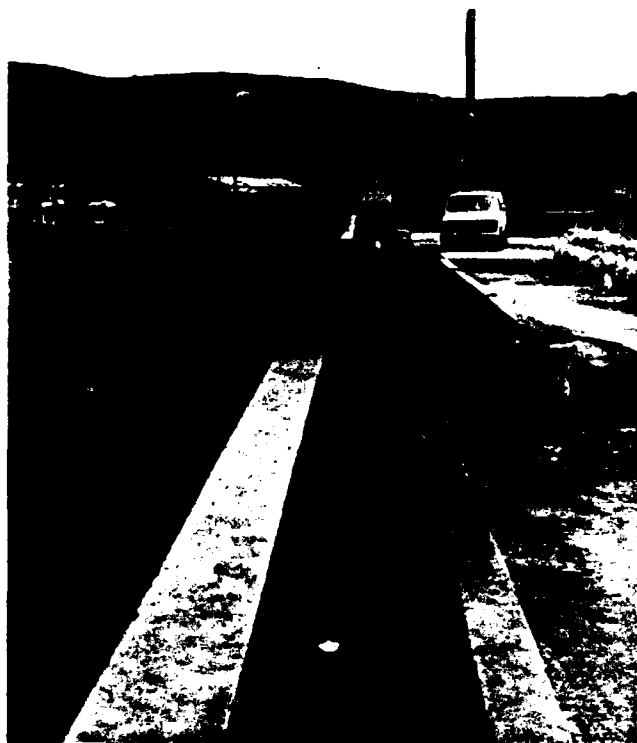
# NEW NORTH DOLPHIN

Looking north at the extreme northwest corner of  
the steel channel cap, bent down by a ship, warp-  
ing on departure.

1. Additional concrete crack repairs were made to the underdeck of the Approach Roadway (Sheet 3).
2. At Mooring Dolphin No. 1 (a circular sheetpile cell), maintenance work was required for the top two feet of sheeting, underneath the concrete cap (Sheet 3). This portion of the sheeting was first sand blasted and then repainted.
3. At the Loading Platform, the concrete crack repair pattern was modified slightly (Sheet 5).
4. Concrete pipe obstructions were encountered while installing the South Dolphin, which required removal (Sheet 15).
5. As-driven sheetpile tip elevations were noted (Sheets 13, 14 and 15).
6. The corner bracket detail for the fendering was modified slightly (Sheets 18, 21 and 30).
7. A specially fabricated fender unit was installed at the northwest corner of the North Dolphin, to protect this corner from impact, during ship departures (Sheet 29).

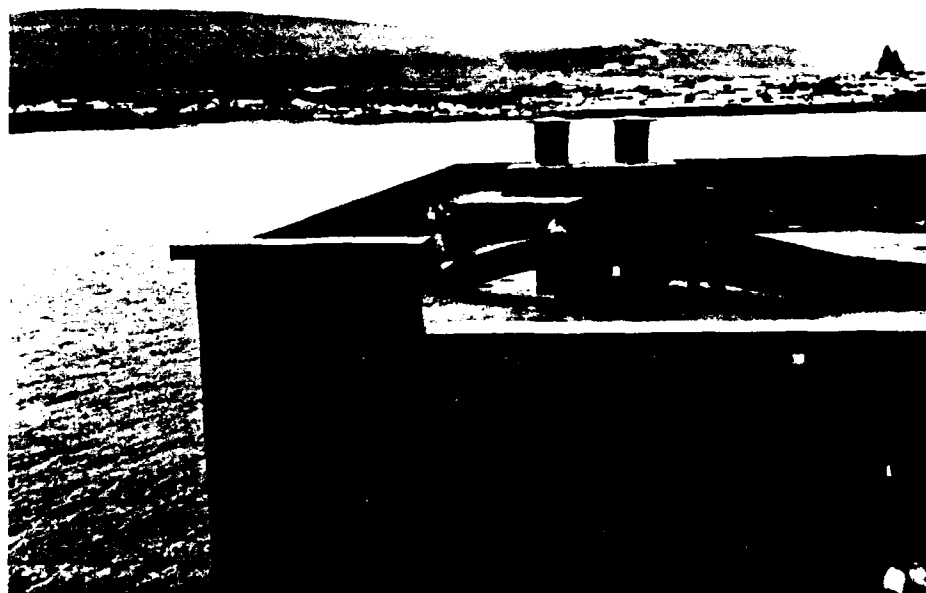
NEW SOUTH DOLPHIN  
Looking west at south end showing the construction details and hoses.

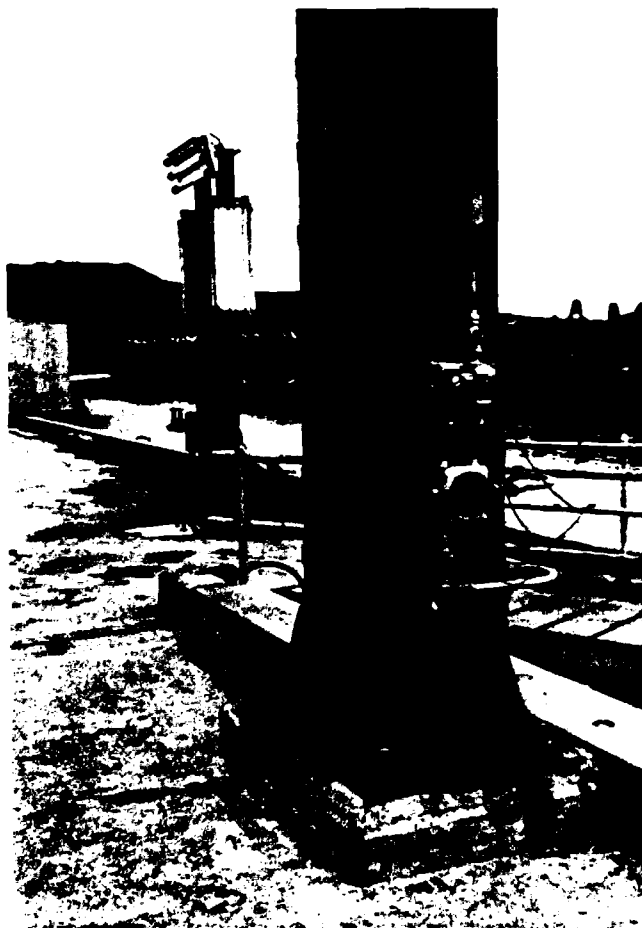
#### NEW SOUTH DOLPHIN

Looking south along the east face. Note that the top of the steel sheet piling was bent in, beneath the steel channel cap.
